Contamination Screening Evaluation Report

SR 9/I-95 at Central Boulevard Interchange **PD&E Study**

I-95 from north of PGA Boulevard (MP 36.783) to Donald Ross Road (MP 40.163)

October, 2016

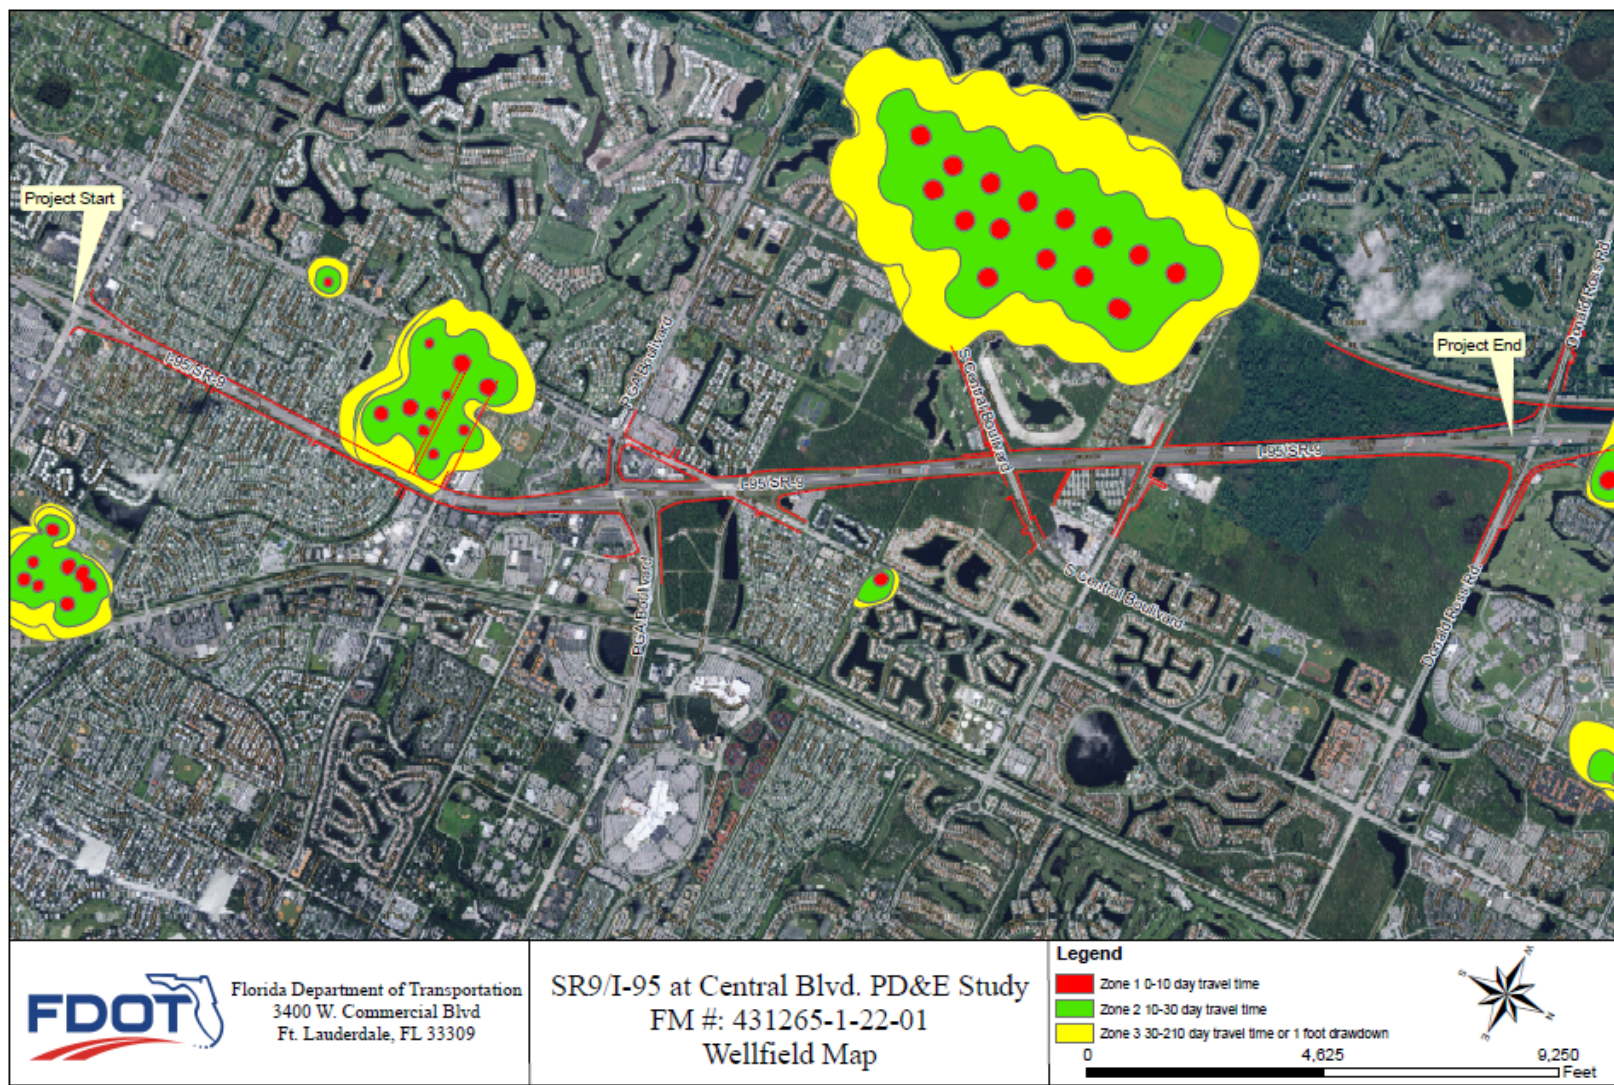
Figure 14 Wellfields

The proximity of the project corridor to public wellfields and surface water bodies was investigated. According to the Palm Beach County Existing Wellfield Protection Zone Map (2013) (see **Figure 14**), the project is located within ¼ mile of the Seacoast Utilities Authority wellfield. Facilities that store, use, handle or produce regulated substances in the wellfield zones are required to obtain a Hazardous Material Wellfield License and are routinely inspected by the County. The license requires recordkeeping, notifications, training, ground water and raw water monitoring and a spill contingency plan. (The handling and use of regulated substances when used for paving road surfaces is exempt from licensing requirements.) Additionally, reclaimed water and untreated water cannot drain to the ground or be allowed to flow to within 100 feet from an existing water well.

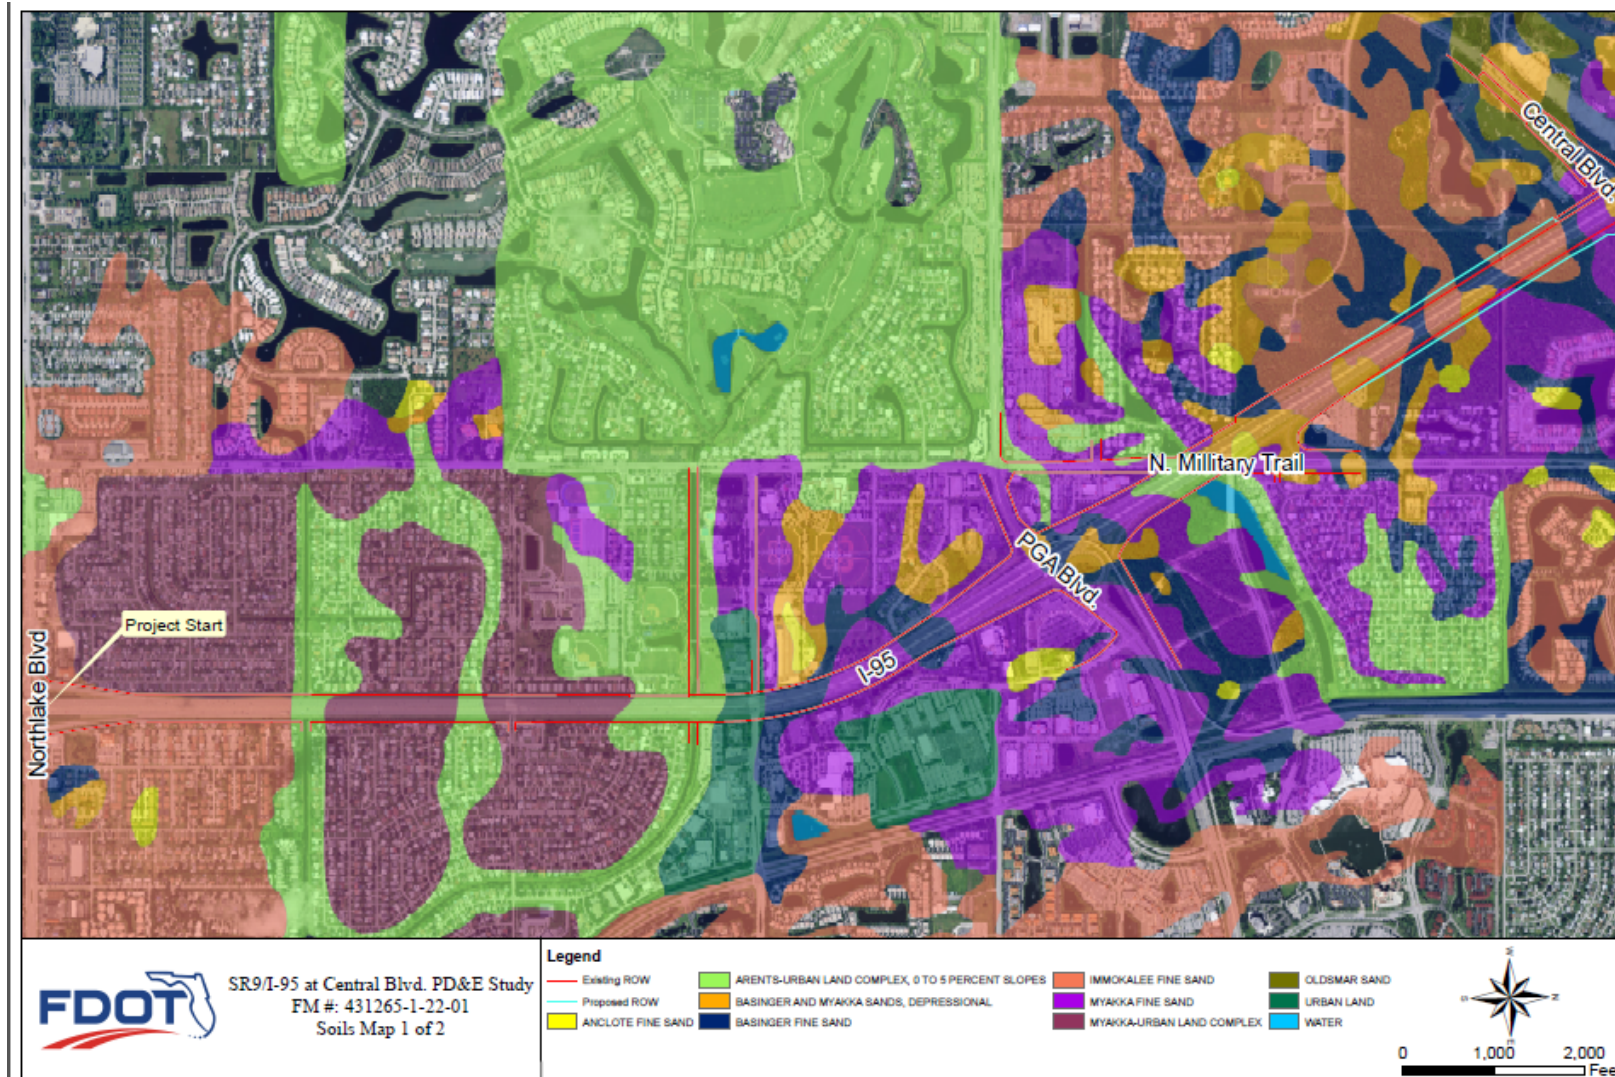
Figure 15 Soils - Northlake Blvd. to Central Blvd.

According to the Natural Resources Conservation Service (NRCS) database and illustrated in the Soils Map below (see **Figure 15** and **Figure 16**), the project corridor is dominated by Myakka Fine Sand comprising approximately 21.97% of the soil types encountered, followed by Basinger and Myakka Sands comprising approximately 19.10% and Immokalee Fine Sand comprising approximately 18.28%. **Table 1** shows the respective acreages and percentages of each soil type.

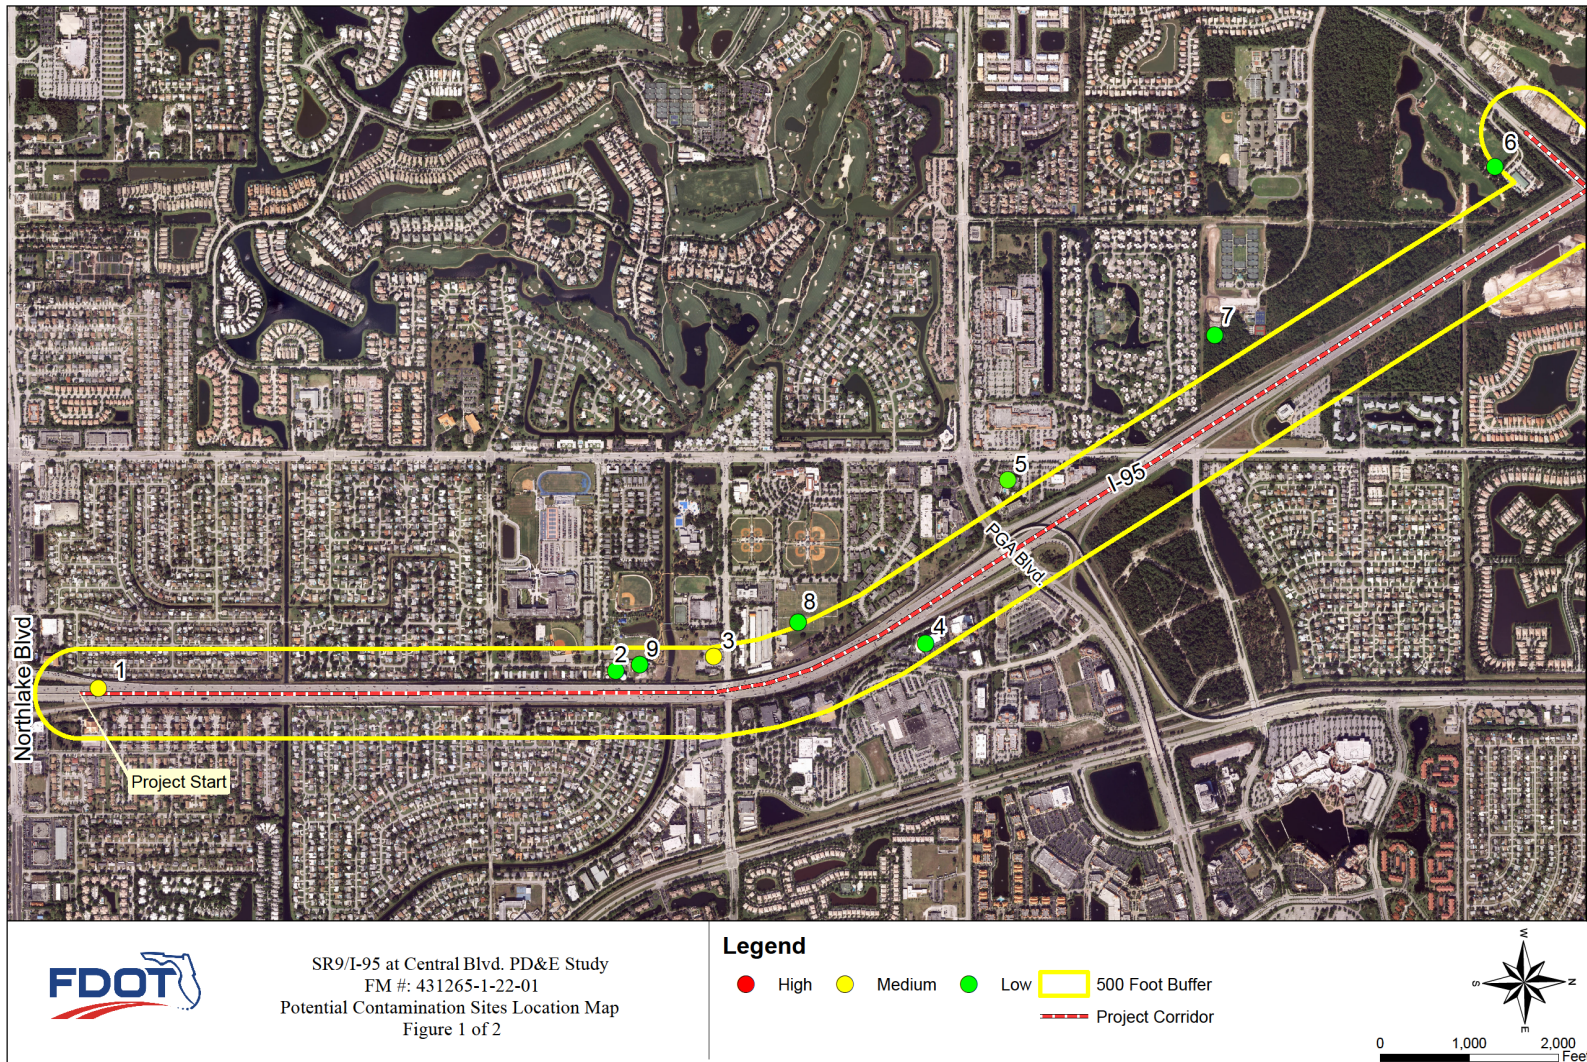
Figure 17 Potential Contamination Sites – Northlake Blvd. to Central Blvd.

MAP ID	Name	Address	Contamination Type	Site ID	Risk Rating
1	Gunther Transport	0.1 mile north of Northlake Blvd. on I-95	Spill Site	9602407	Medium
2	Seacoast Utilities / Lilac Street Water Treatment Plant	4075 Lilac Street, Palm Beach Gardens	FDEP STCM	9200294	High
3	Ra Co Amo, Inc.	4100 Burns Road, Palm Beach Gardens	USEPA RCA FDEP Haz waste facility	FLD984184432	Medium
4	Corporate Center at the Gardens / Wackenhut	4200 Wackenhut Drive, Palm Beach Gardens	FDEP STCM	9805394	Low
5	Doubletree Hotel	4431 PGA Boulevard, Palm Beach Gardens	FDEP STCM	9801413	Low
6	Old Palm Golf Maintenance	11962 Central Boulevard, Palm Beach Gardens	FDEP STCM	9806455	Low
7	Reduction Site #6 – City Park	5070 117 th Court North, Palm Beach Gardens	Solid Waste Facility (Disaster Debris Staging)	100014	Low
8	Reduction Site #3 – Gardens Park Debris Staging Area	4404 Burns Road, Palm Beach Gardens	Solid Waste Facility (Disaster Debris Staging)	98341	Low

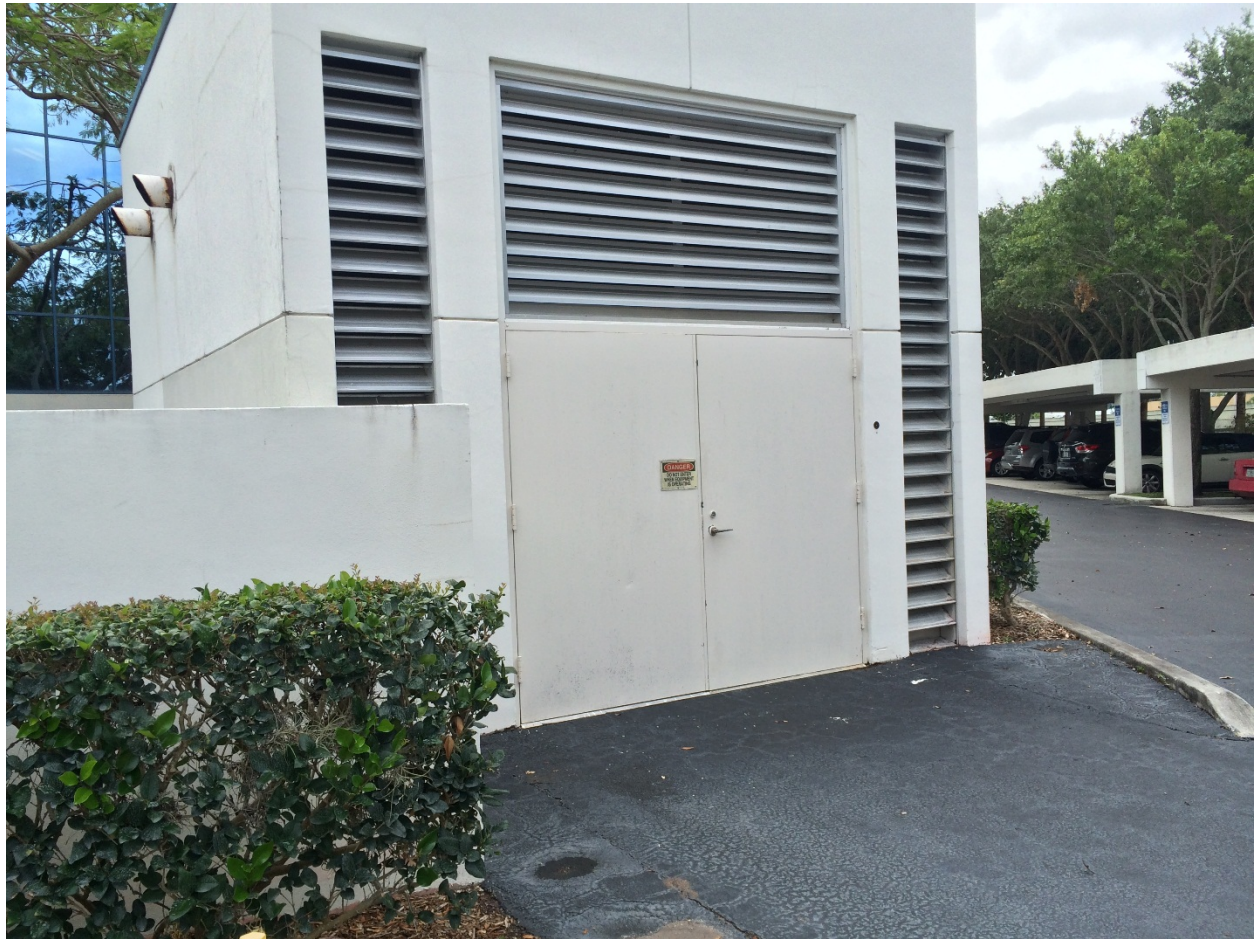
Site #4, Corporate Center at the Gardens / Wackenhut, 4200 Wackenhut Drive

This site is located to the east of I-95 and has one 1,250 gallon capacity aboveground storage tank used to fuel an emergency generator, installed in 1995 and registered in 2002. The most recent Storage Tank Facility Annual Compliance Inspection in March 2015 revealed the facility was in compliance. Due to presence of an aboveground storage tank at this facility, but an absence of documented contamination or violations, this site is assigned a **LOW** environmental risk rating.

Emergency generator building housing aboveground diesel storage tank.

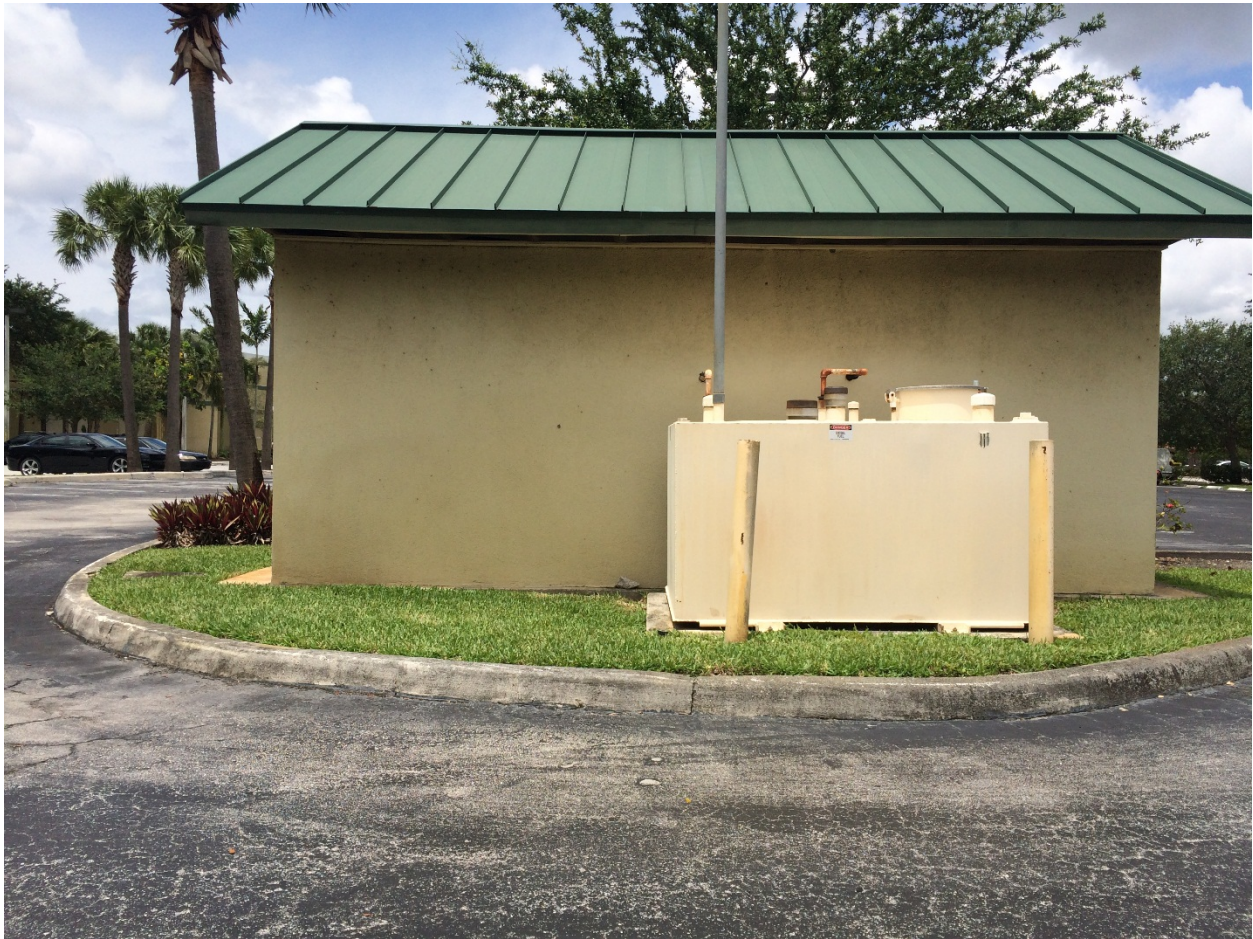
Site #5, Doubletree Hotel, 4431 PGA Boulevard

This site is located on the north side of PGA Boulevard, to the west of I-95. This facility had one 350 gallon capacity underground diesel storage tank that was installed in 1971, and one 270 gallon capacity temporary aboveground storage tank installed in 1999 to replace the UST, which was removed from service. An FDEP storage tank compliance inspection in March 1999 stated that the facility was out of compliance due to failure to register tanks, failure to demonstrate financial responsibility, and using a bare steel UST after the cutoff

Aboveground diesel storage tank.

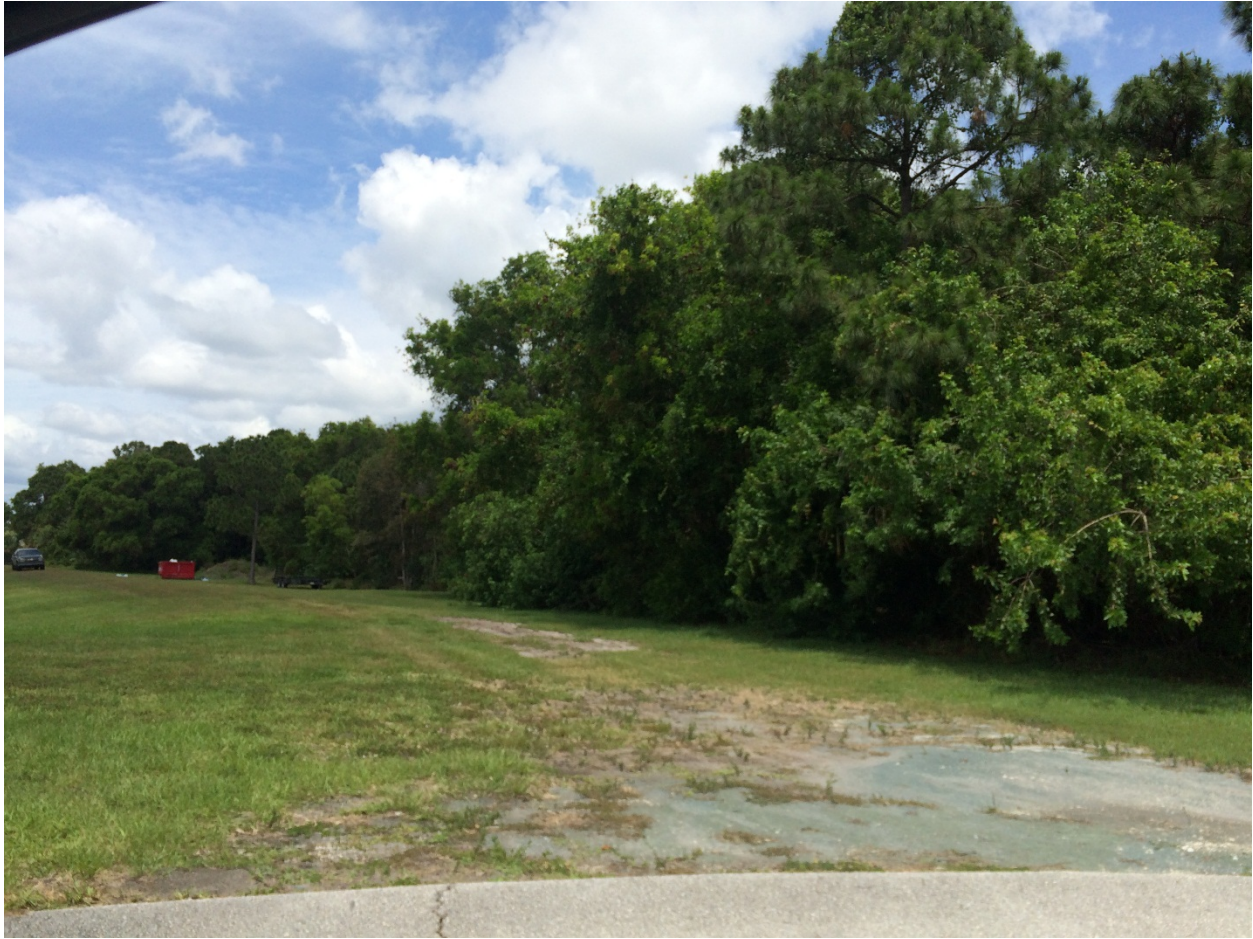
Site #7, Reduction Site #6, City Park, 5070 117th Court North

Reduction Site #6 - City Park is an inactive disaster debris staging area, formerly located west of I-95. Based on this facility's former use as a non-hazardous debris staging site and current regulatory status, this site is rated as **LOW** risk.

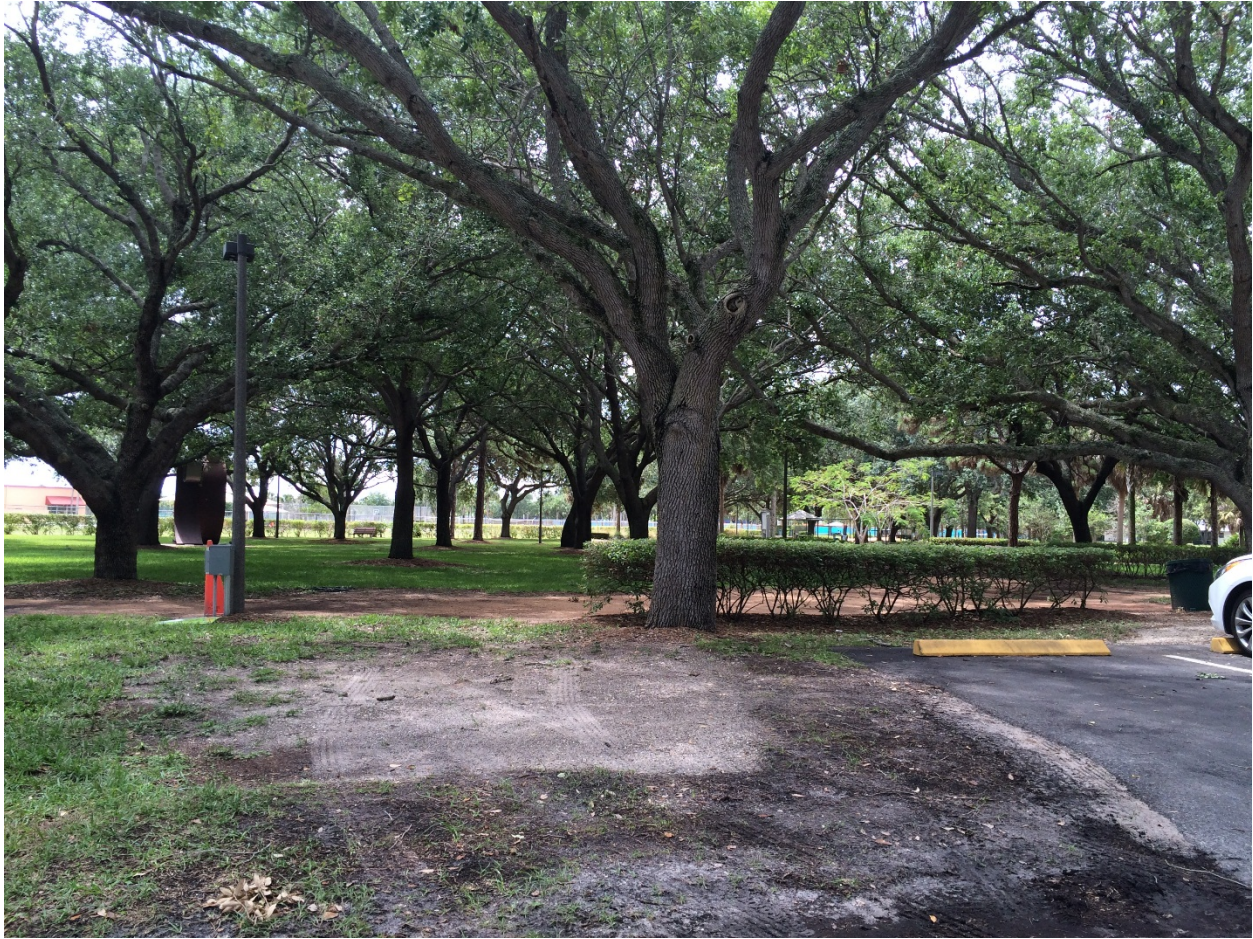
Site #8, Reduction Site #3, Gardens Park Debris Staging Area, 4404 Burns Road

Reduction Site #3 - Gardens Park Debris Staging Area is an inactive disaster debris staging area, formerly located west of I-95 on the north side of Burns Road. Based on this facility's former use as a non-hazardous debris staging site and current regulatory status, this site is rated as **LOW** risk.

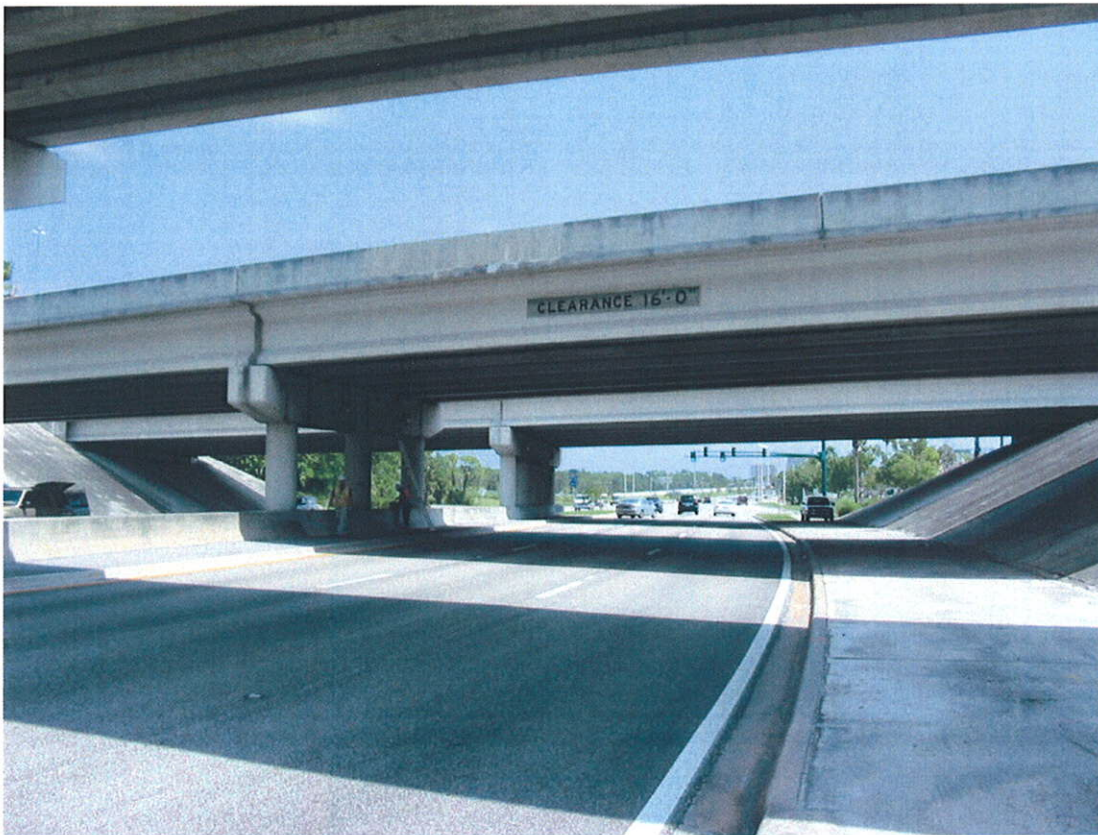
Drawn CM	Job # 06000-07783
Checked JM	Figure P-2
Date 10/16/06

Upper Photo:
SR-9/1-95 & PGA Boulevard
Bridge No. 930335

Lower Photo:
Neoprene Bearing Pad - End Bent

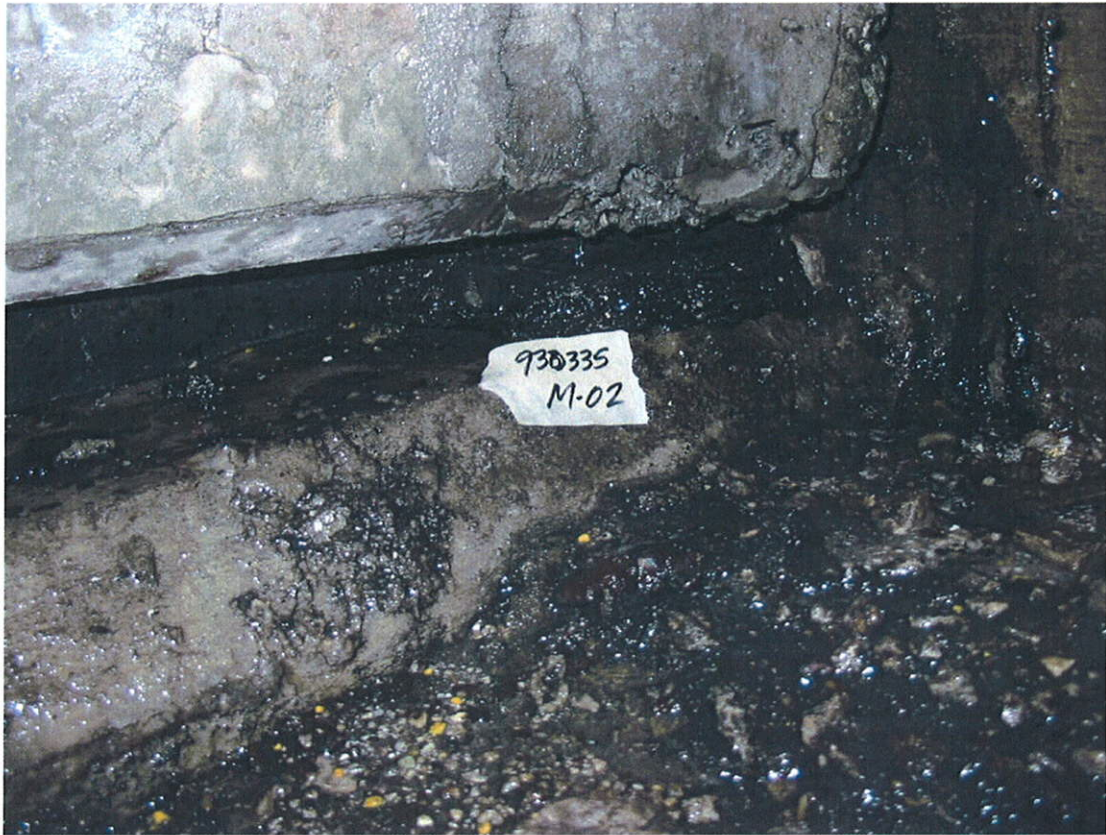
Drawn	Job #
CM	06000-07783
Checked	Figure
JM	P-3
Date	
10/16/06

Upper Photo:
Particle Board Bearing Pad – End Bent

Lower Photo:
Neoprene Bearing Pad – Intermediate Bent

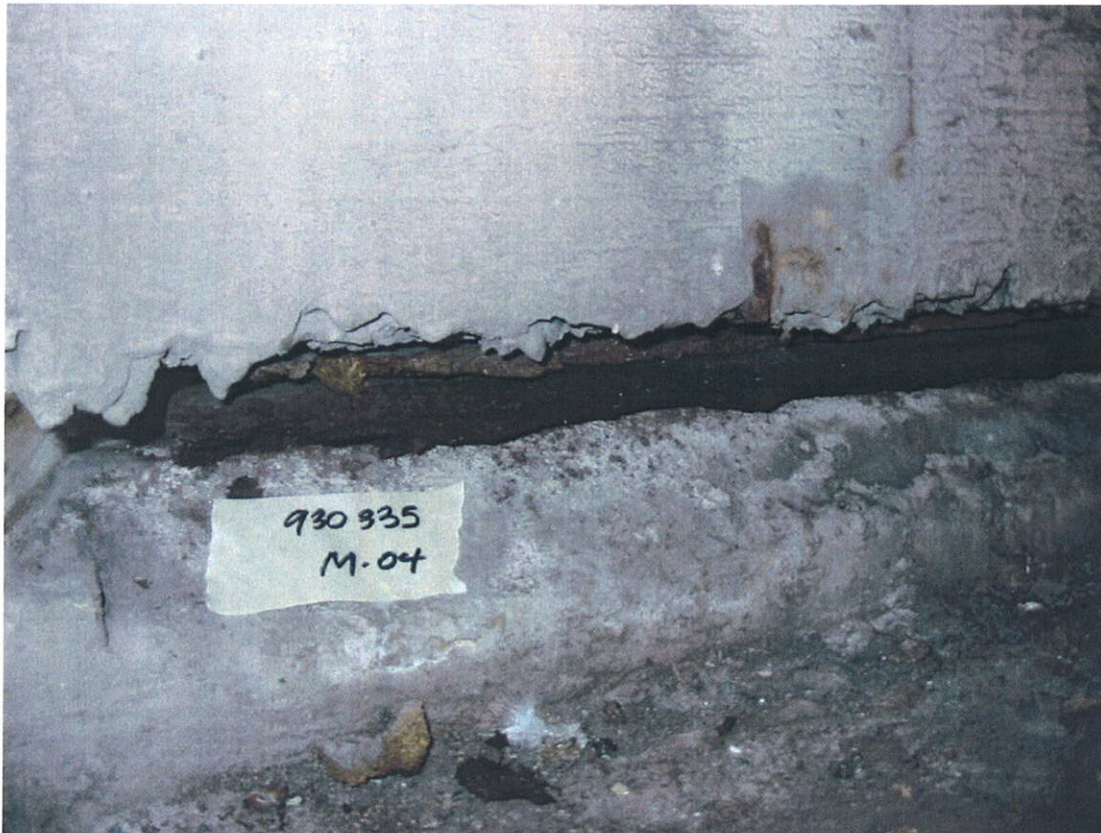
Drawn CM	Job # 06000-07783
Checked JM	Figure P-4
Date 10/16/06

Upper Photo:
Particle Board Bearing Pad – Intermediate
Bent
Lower Photo:
Black Hot Bitumen – Slope Pavement

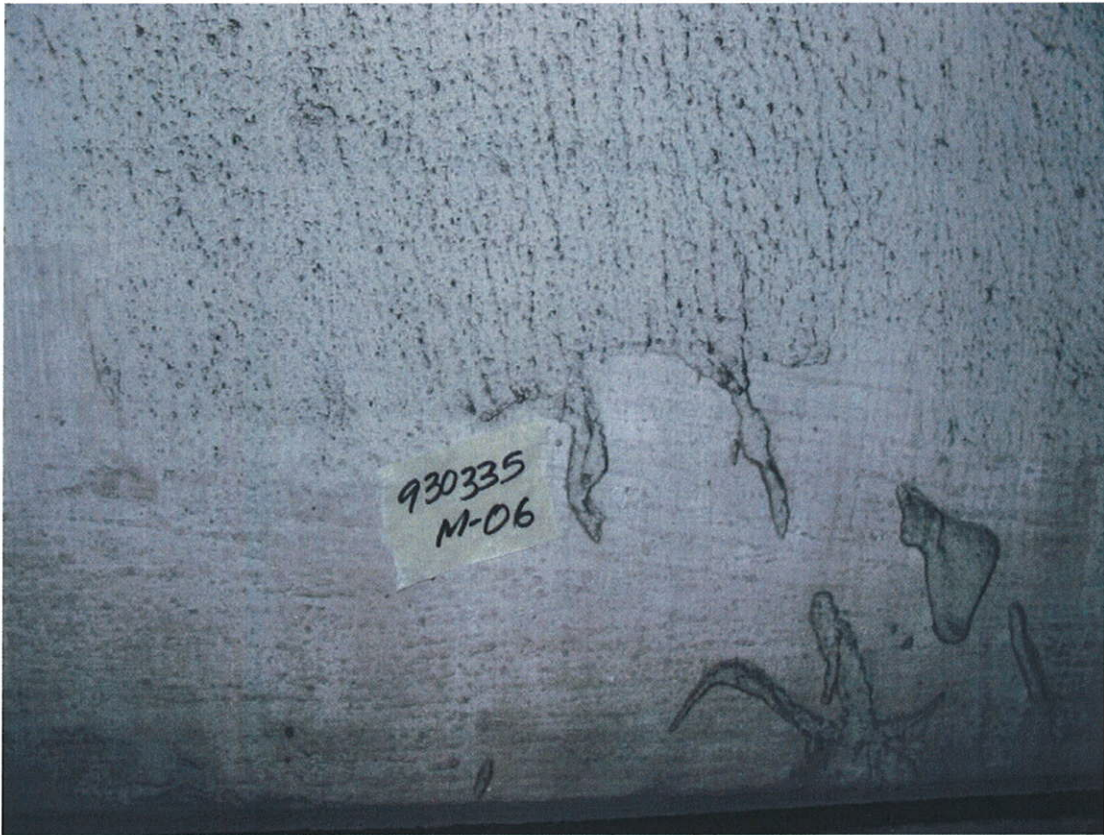
Drawn CM	Job # 06000-07783
Checked JM	Figure P-5
Date 10/16/06

Upper Photo:
Class 5 Finish – End Bent

Lower Photo:
Class 5 Finish – Beam & Deck Seam

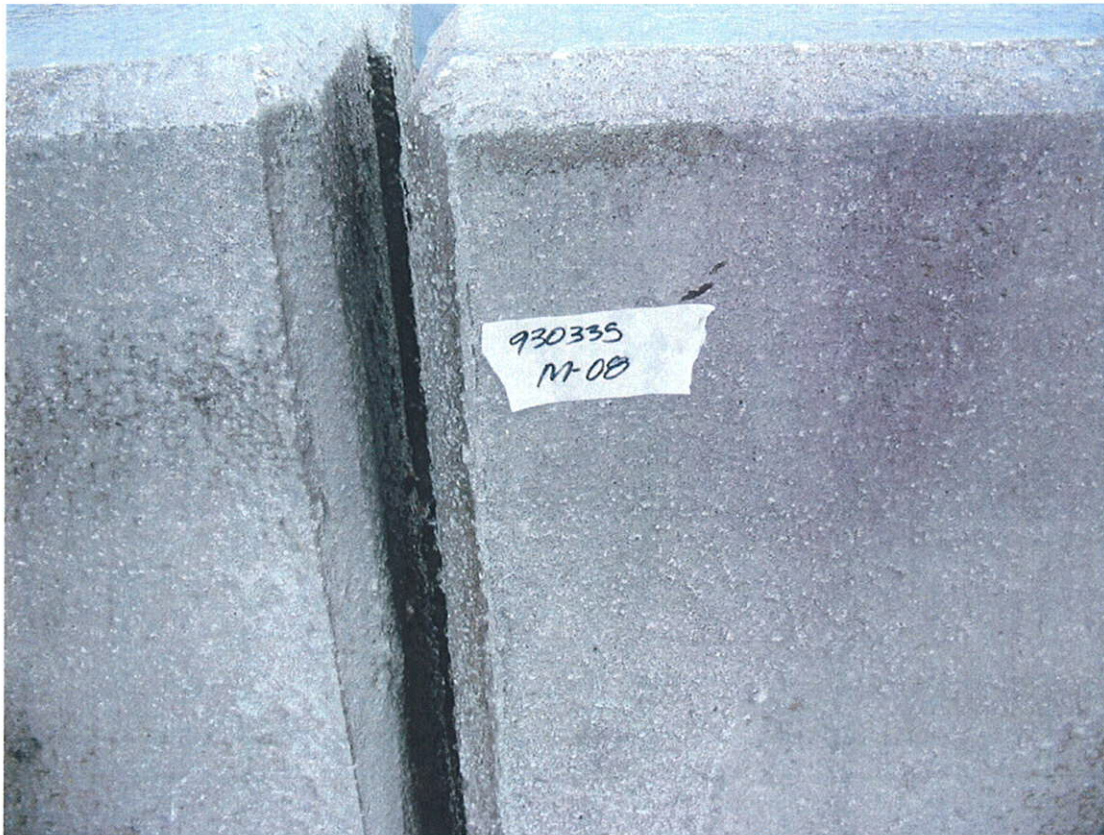
Upper Photo:
Class 5 Finish – Parapets

Lower Photo:
Class 5 Finish – Beam Span

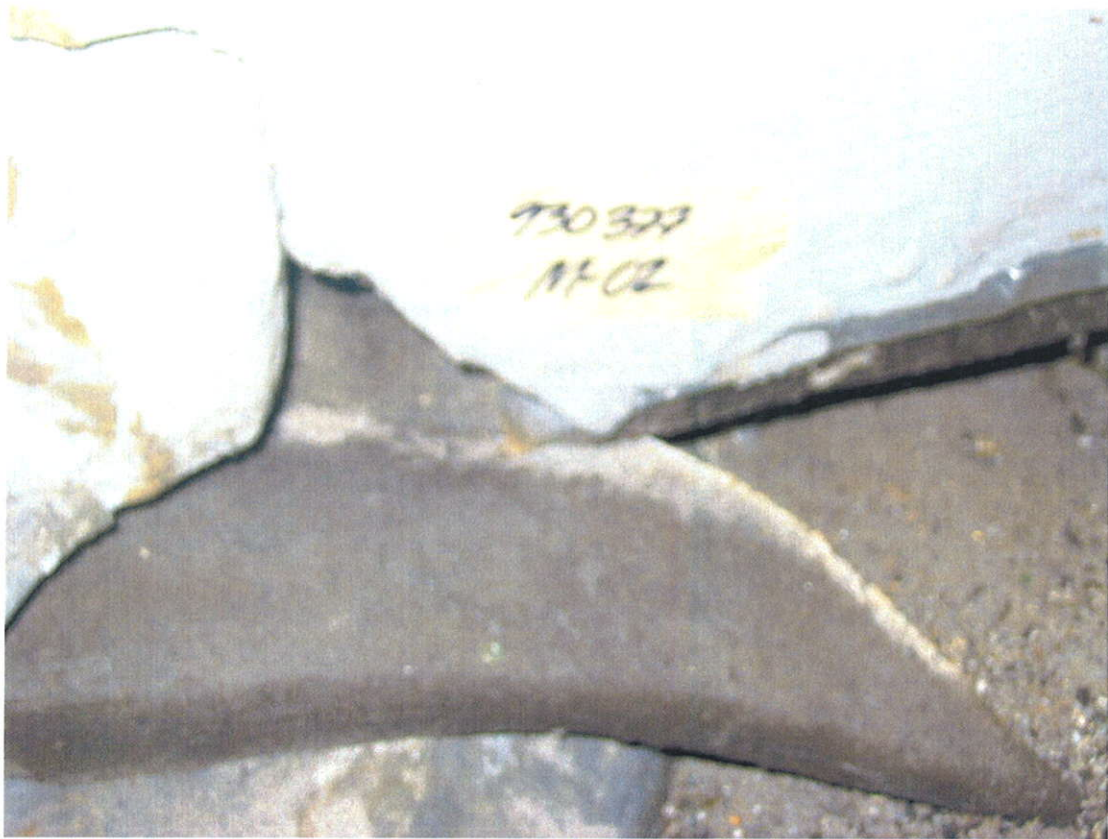
Drawn	CM	Job #	06000-07783
Checked	JM	Figure	P-3
Date	10/16/06

Upper Photo:
Particle Board Bearing Pad – End Bent
(Intermediate Bent Bearing Pads Not Accessible)
Lower Photo:
Black Hot Bitumen – Slope Pavement

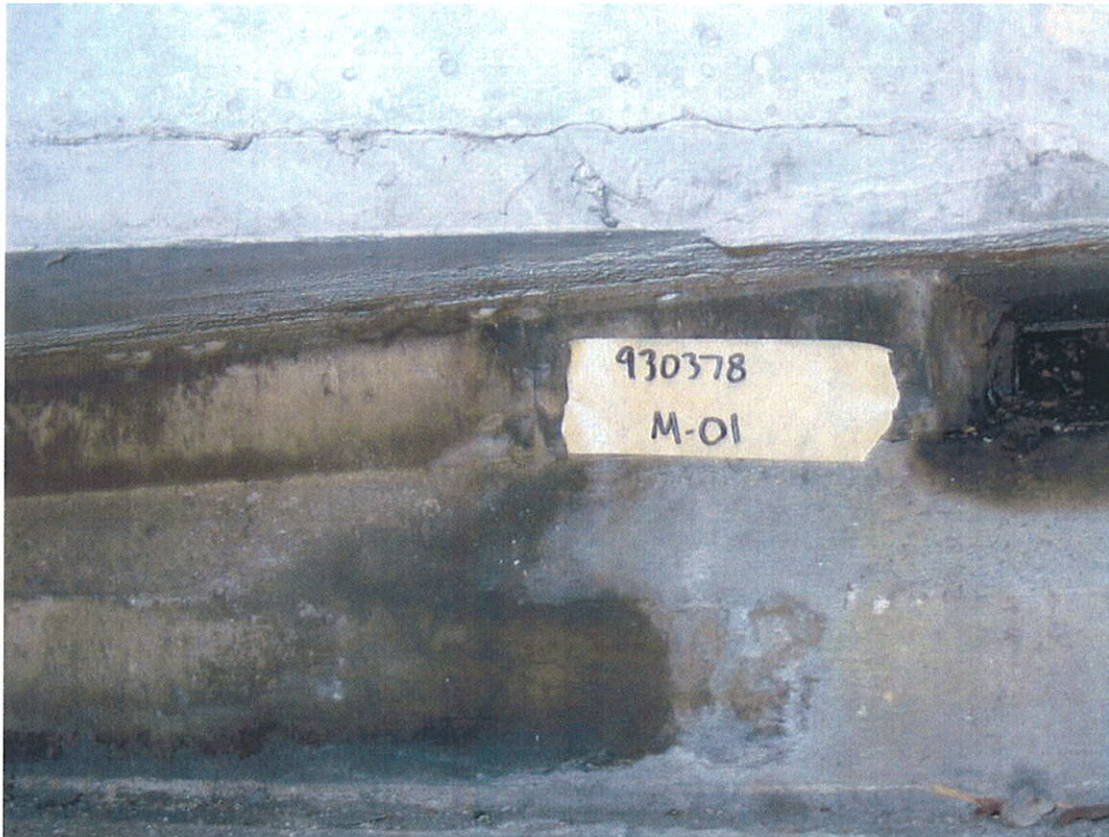
Drawn CM	Job # 06000-07183
Checked JM	Figure P-3
Date 10/16/06

Upper Photo:
Neoprene Bearing Pad – End Bent
(Intermediate Bent Bearing Pads Not Accessible)
Lower Photo:
Particle board Bearing Pad – End Bent
(Intermediate Bent Bearing Pads Not Accessible)
